Manhole Inspection Summary

Manhole # S23II_040MH

Insp Date: **9/28/07 2:25 PM**

Location Address: **2206 PENNSYLVANIA AVE**

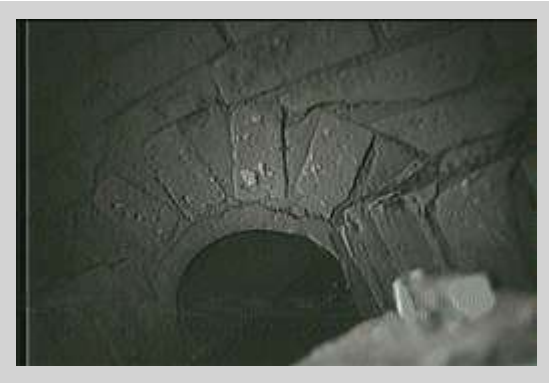
8 in. Circular Gravity Sewer Pipe Out @ 12 O'Clock

Invert Depth: **10.00** (ft.) Flow Characteristics: **Fast**

Deposits: ☒ None ☐ Mud ☐ Sludge ☐ Debris ☐ Grease

Infiltration: **None** Pipe Seal Cond: **Unknown**

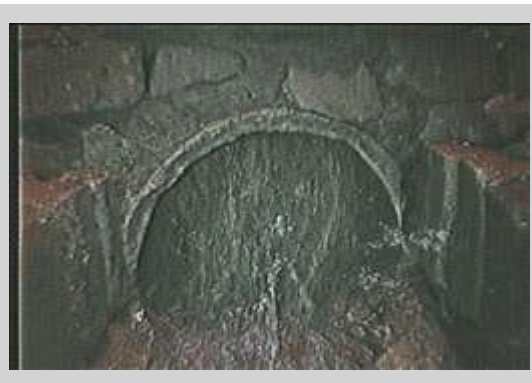
Drop In @ 6 O'Clock

Drop: **Outside** Rod and Bar

Angled: **Yes** Reading: **8.79** (ft.)

Drop Condition: **Open**
